LPC# 1210500002 Marion County
Sandoval Zinc Co. - Sandoval
ILD 053 980 454
F/HRS

Expanded Site Inspection

Sandoval Zinc Company
Box 263 Smelter Road Highway 51, Sandoval, Illinois
ILD 053 980 454

April 5, 2010

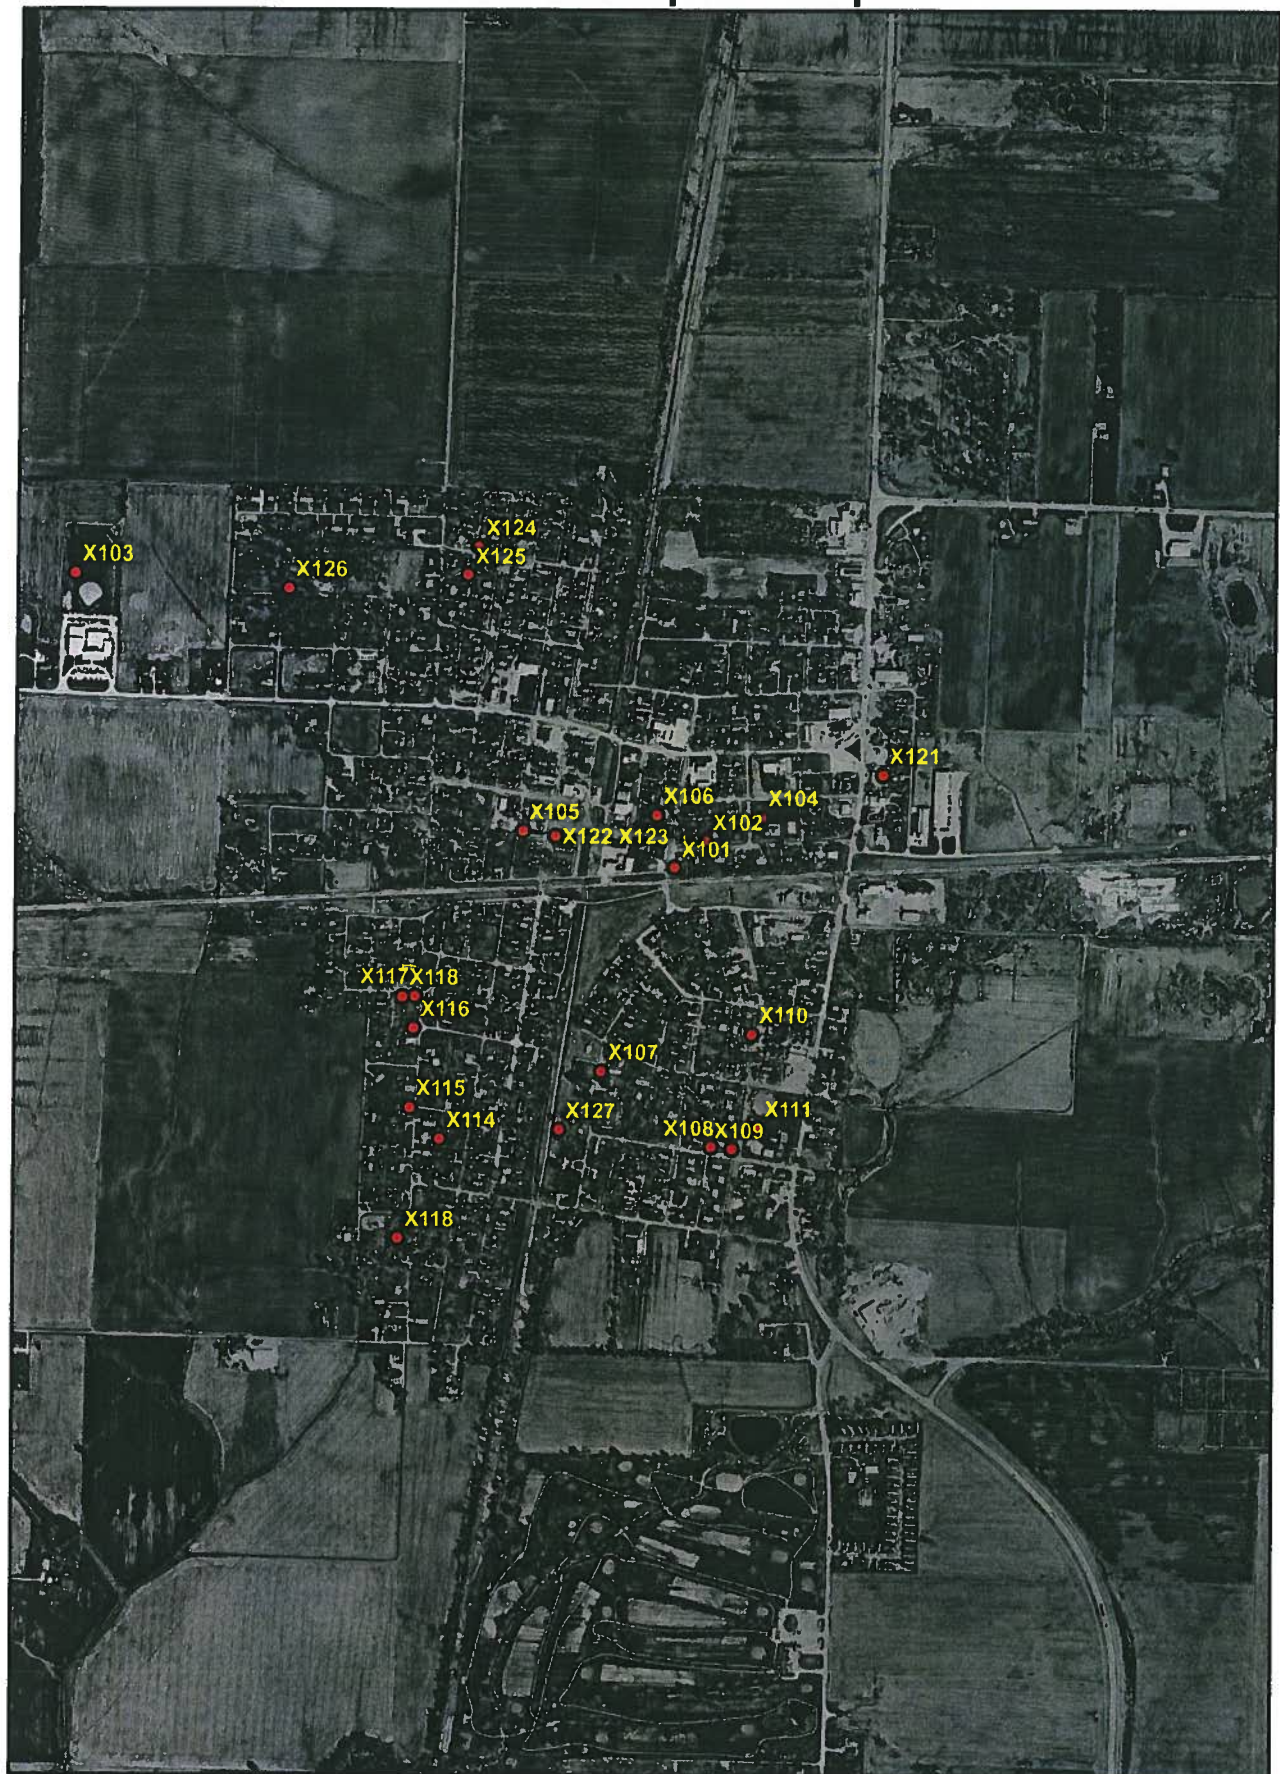
Figure 3
Soil Sample Map

The soil samples were collected with hand trowels and analyzed for the inorganic portion of the Target Compound List. All soil samples were collected within the top six inches of soil. The locations of the soil samples can be seen on Figure 3 and the complete analytical results can be seen in Table 2. Soil samples were collected following the procedures described in the Bureau of Land Sampling Procedures Guidance Manual (p. 6.7 – 6.8).

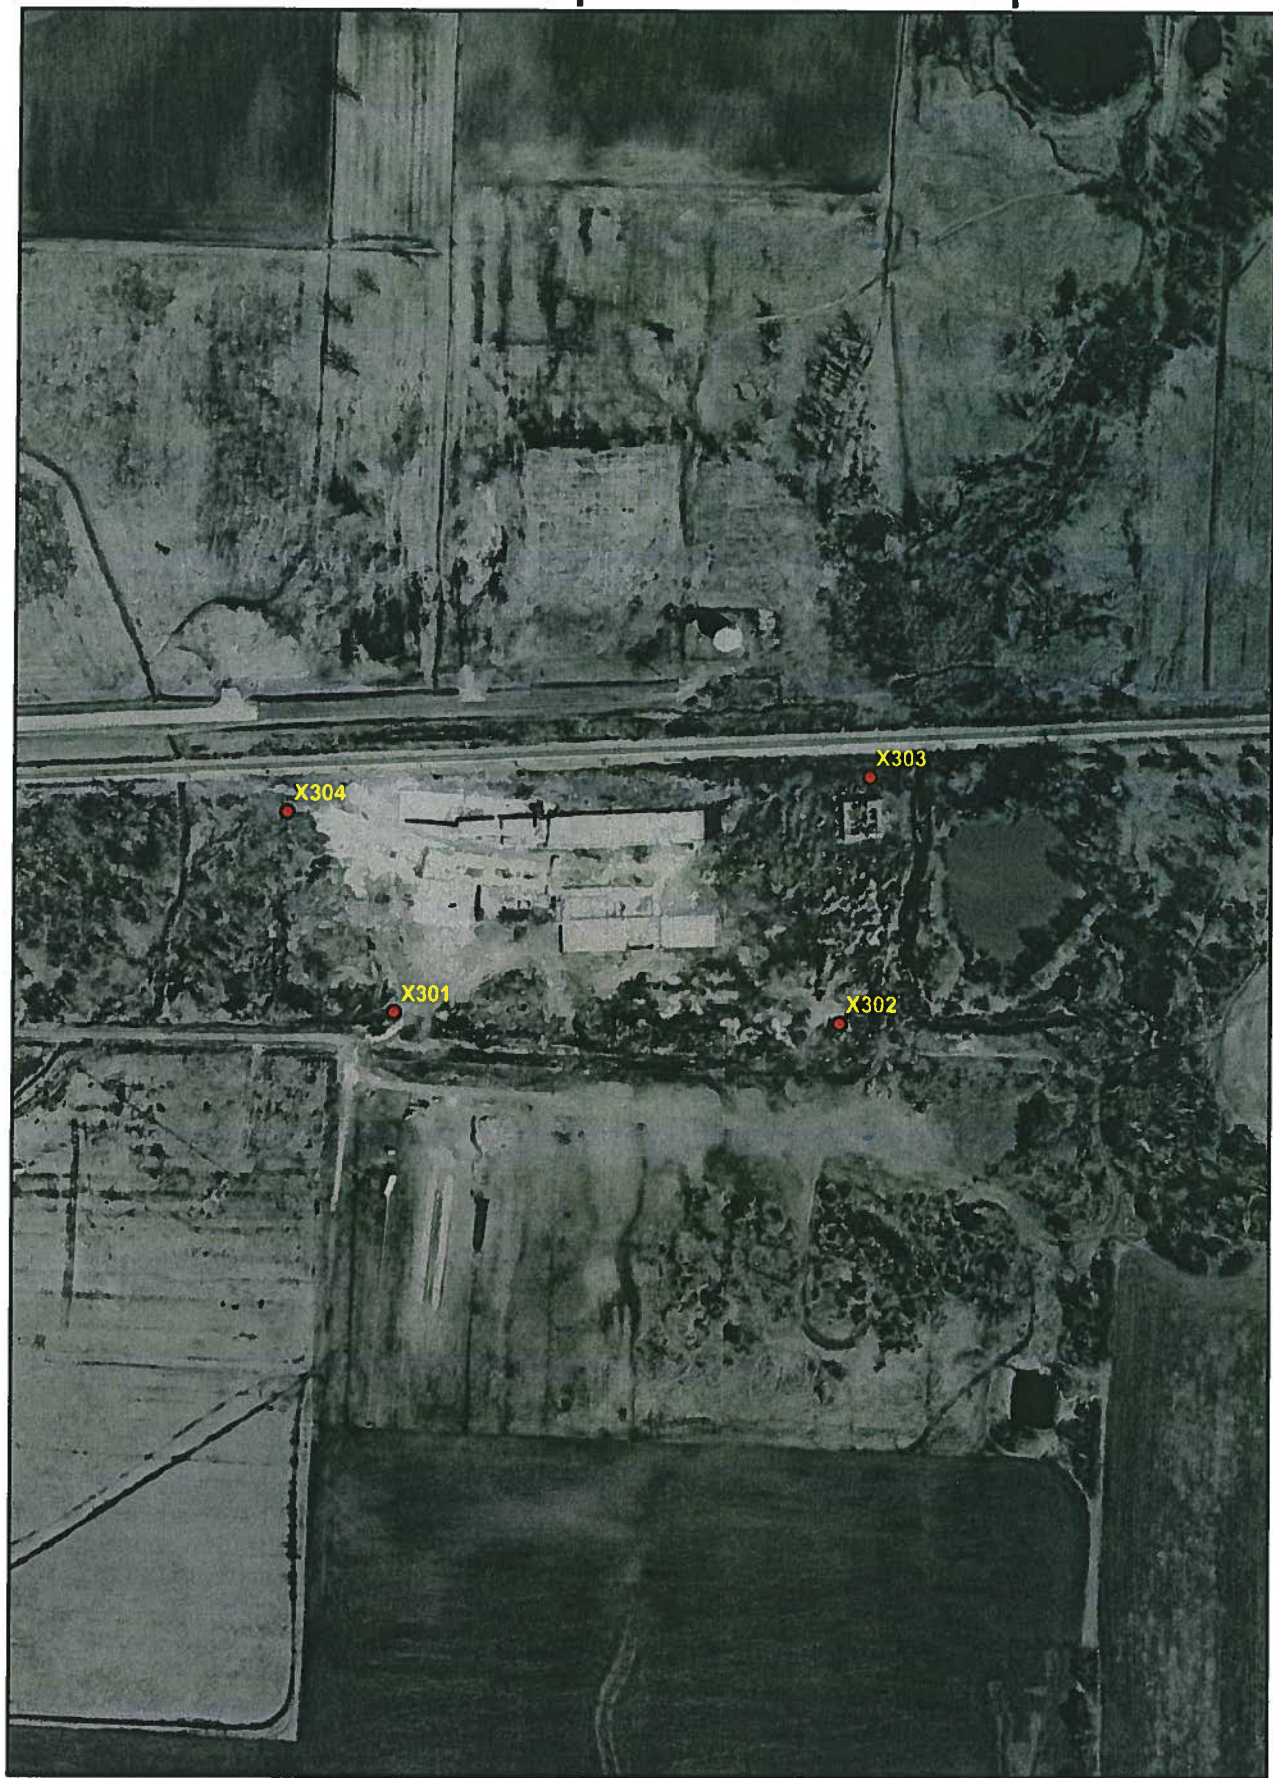
Figure 4
Waste Sample Location Map

Four samples were collected from materials located on the Sandoval Zinc property. These four samples were collected near the four corners of the site property (Figure 4). These samples were collected to help determine the levels of contamination that exist on the Sandoval Zinc property that could potentially migrate to environmental receptors. These samples were

collected with hand trowels and were analyzed for the inorganic portion of the Target Compound List. The locations of the waste samples can be seen on Figure 4 and the analytical results can be reviewed in Table 3. Waste samples were collected following the procedures described in the Bureau of Land Sampling Procedures Guidance Manual (p. 5.7 – 5.8).

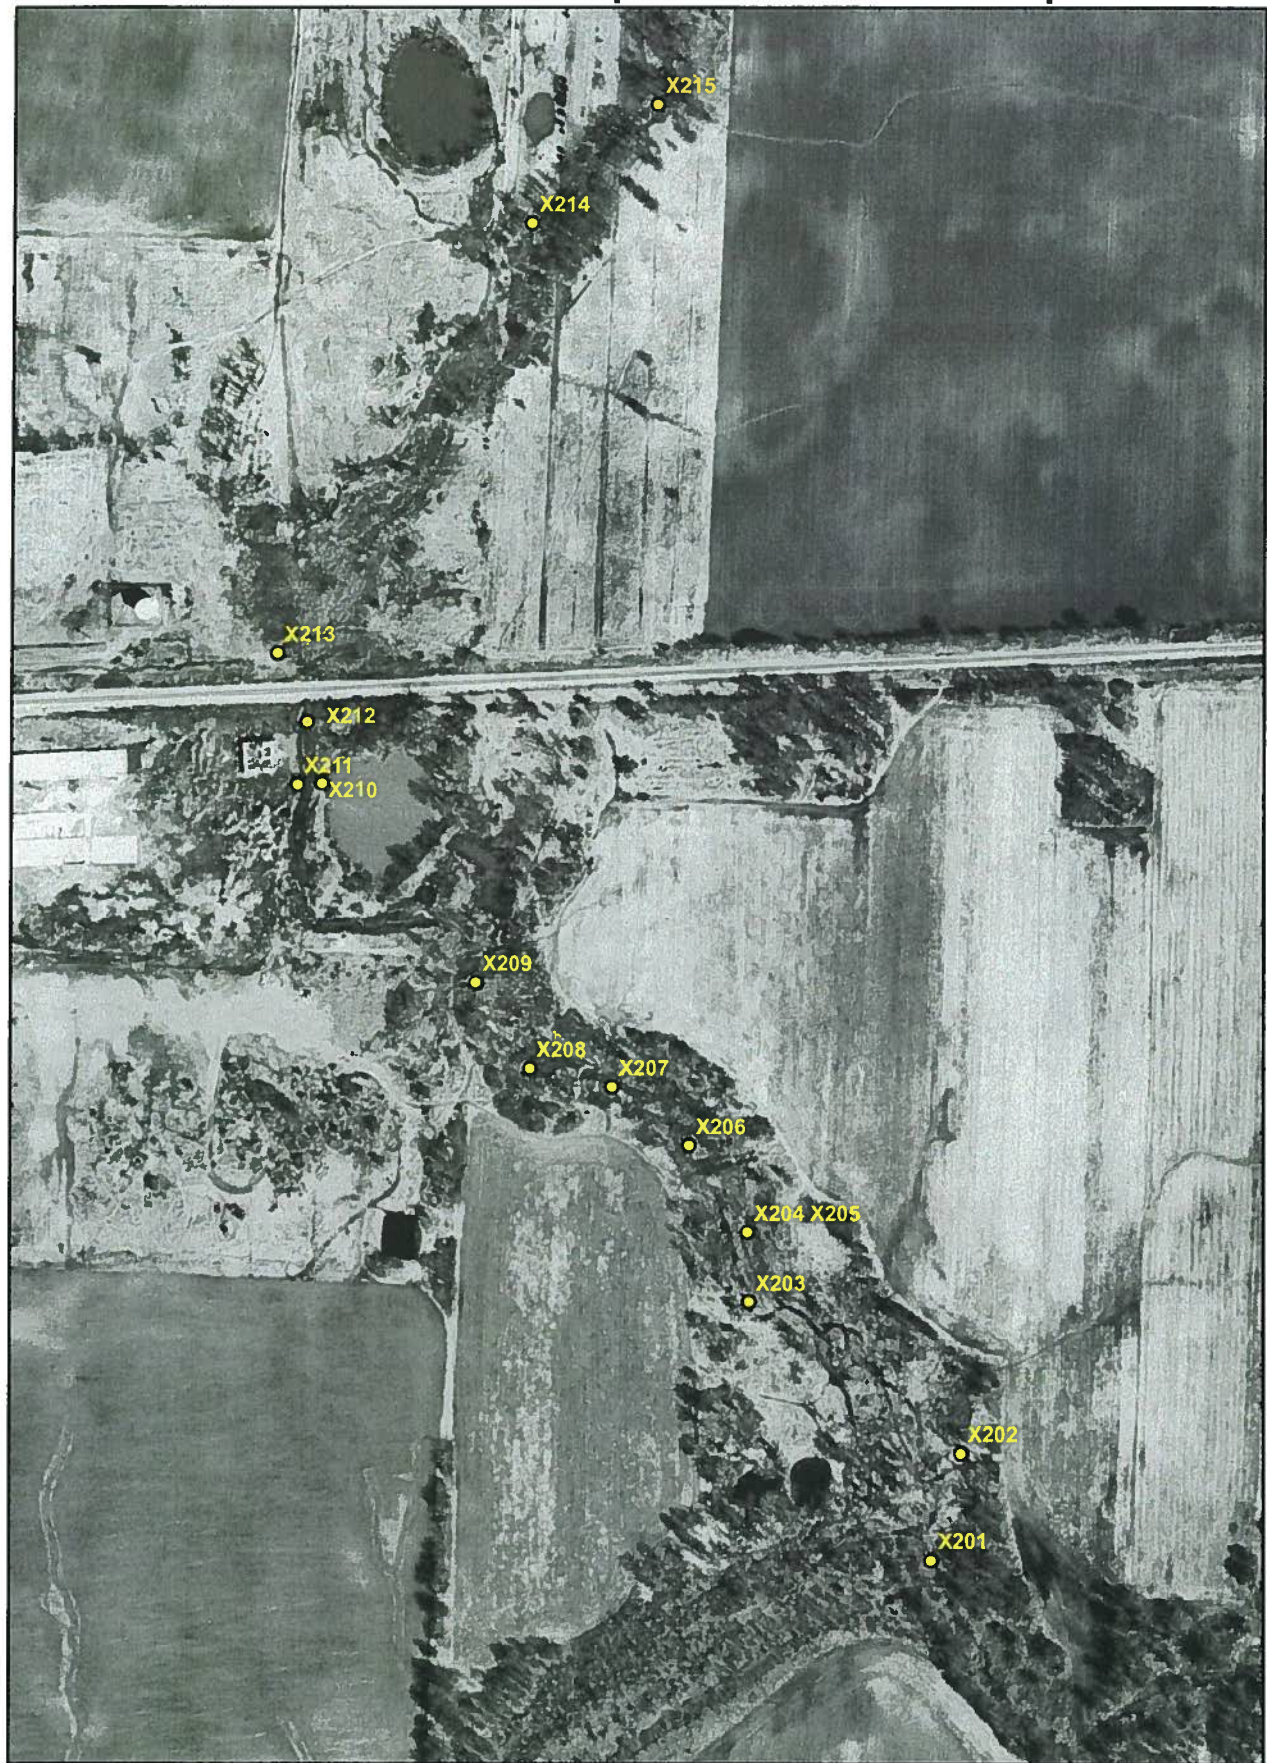
Figure 5
Sediment Sample Location Map

In October 2009, fifteen sediment samples were collected from the drainage area to the east of Sandoval Zinc in order to determine if contaminants may have migrated from Sandoval Zinc into the adjacent pond and wetlands. These samples were analyzed for the inorganic portion of the Target Compound List. All sediment samples were collected with a hand auger from the top six inches of sediment. The locations of the sediment samples are depicted in Figure 5 and the analytical results can be seen in Table 4. Sediment samples were collected following the procedures described in the Bureau of Land Sampling Procedures Guidance

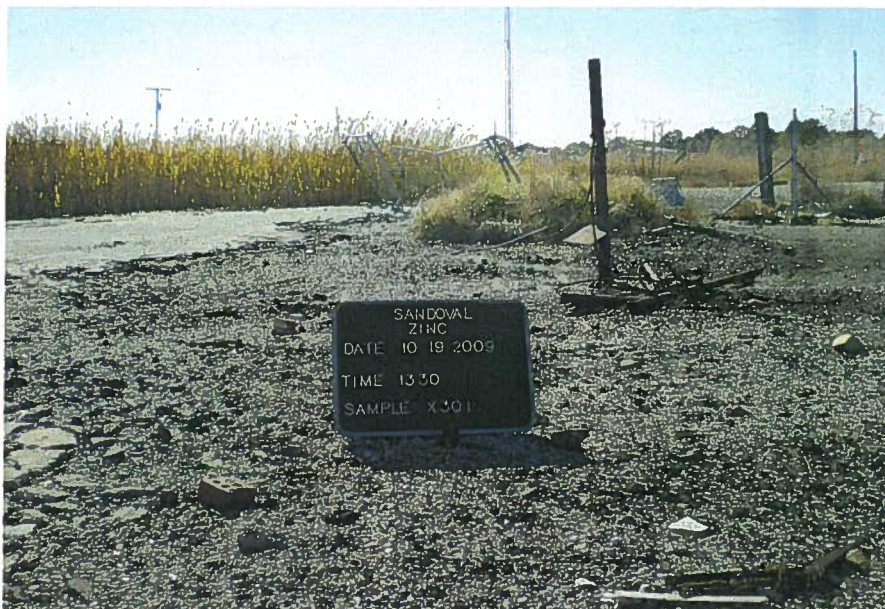
Picture is taken to the southwest of sample X301. This is near the southwest corner of the Sandoval Zinc property. Sample was taken from a depth of 0-2 inches from a light gray material with rocks and gray sand.

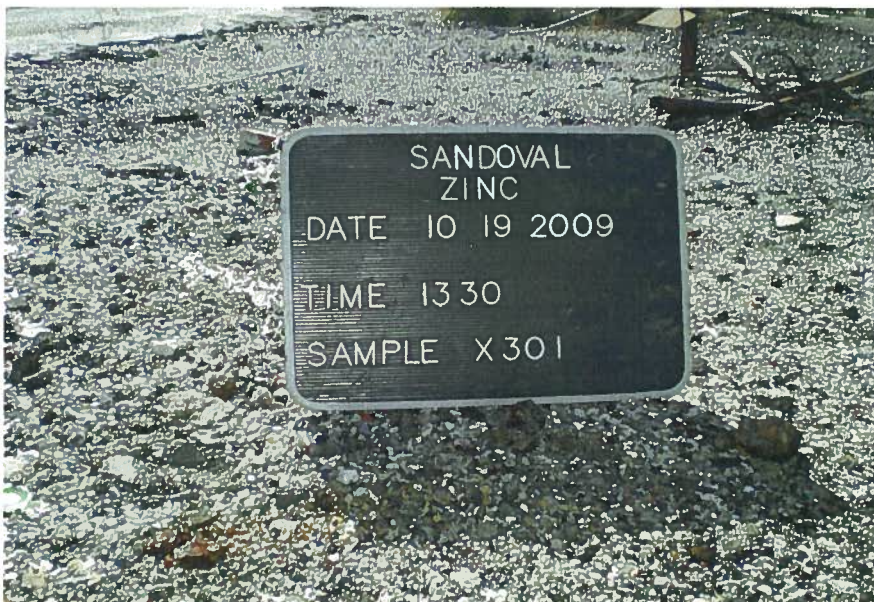
DATE: 10/19/2009
TIME: 1330
PHOTO BY: L. Range
DIRECTION: Southwest

Picture is taken to the southwest of sample X301. This is near the southwest corner of the Sandoval Zinc property. Sample was taken from a depth of 0-2 inches from a light gray material with rocks and gray sand.

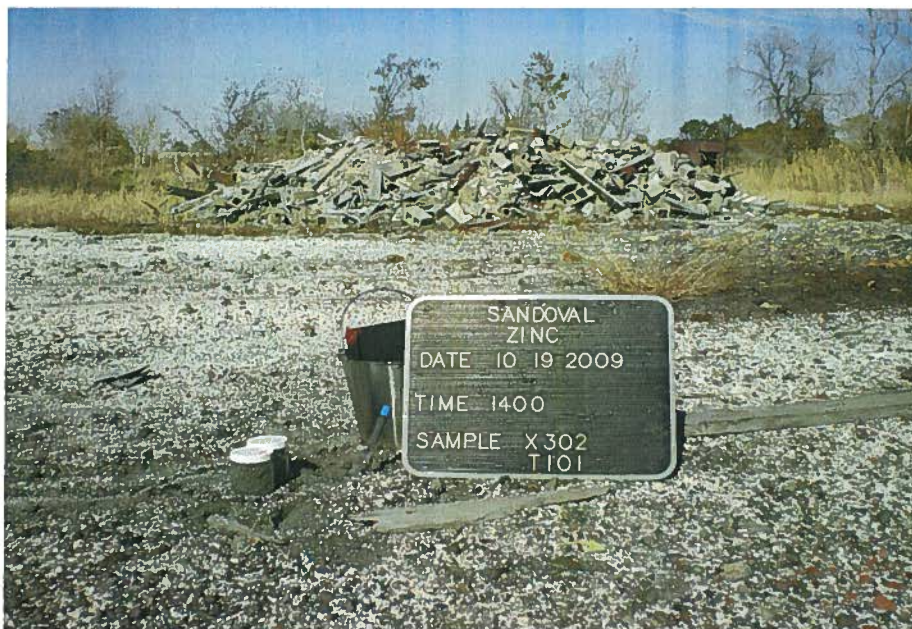
Photo taken of Samples X302 and T101. These samples were collected from 0-2 inches and consisted of a dark gray sandy silt material.

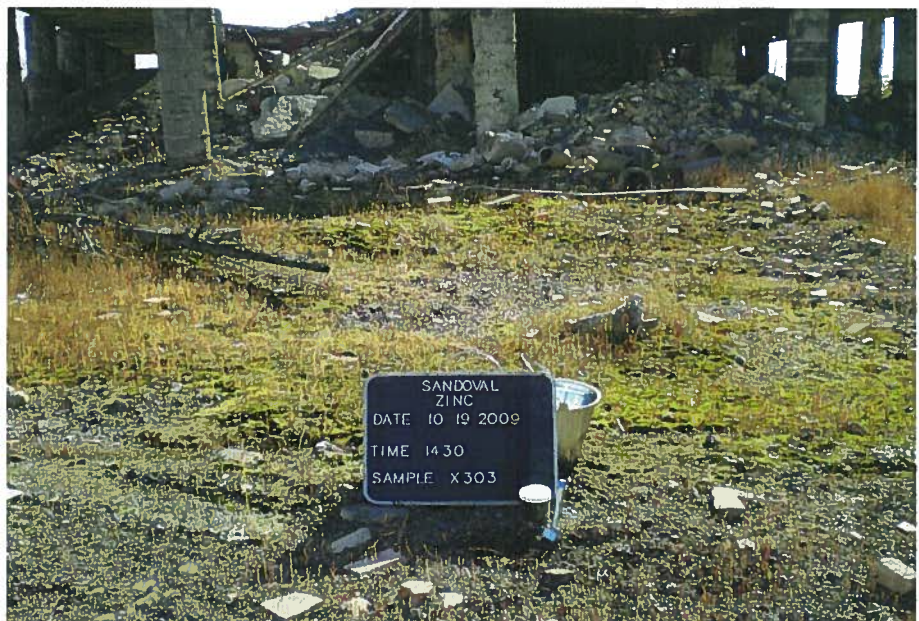
This photo was taken of sample X303 near the northeast corner of the fenced portion of the property. Sample was collected from a depth of 0-2 inches from a black cinder material. Notice the remnants of the furnace in the background.

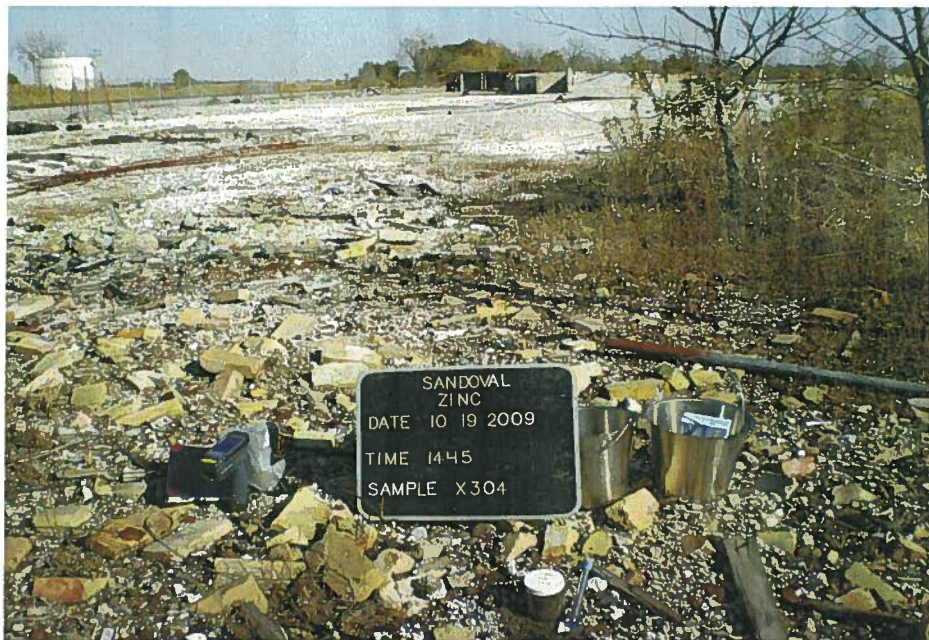
This photo was taken of sample X304. This sample was collected from the northwest corner of the fenced property from a depth of 0-2 inches from a reddish brown sandy material.

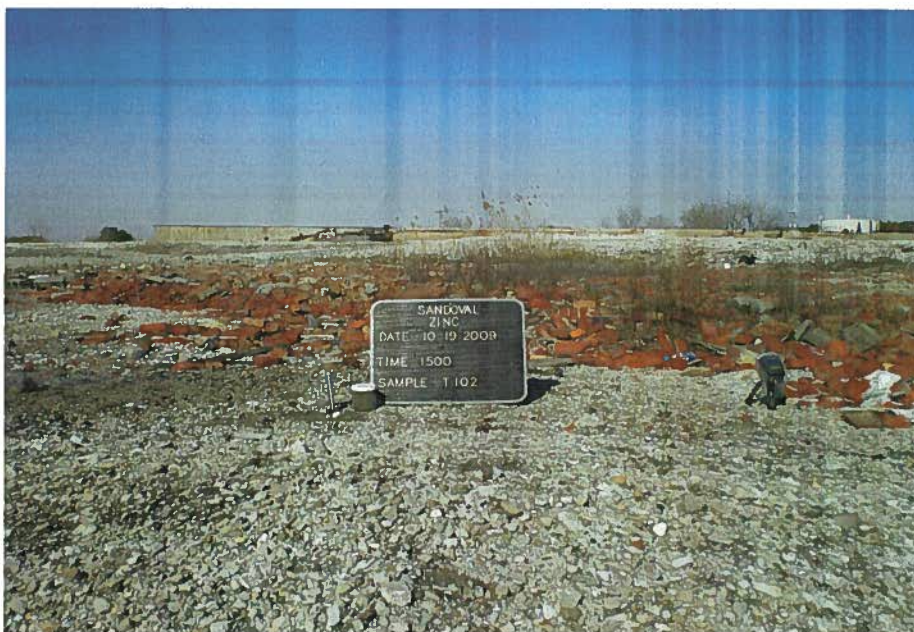
DATE: 10/19/2009
TIME: 1500
PHOTO BY: L. Range
DIRECTION: North

Photo was taken to the north of T102. T102 was collected from a black cindery material from 0-2 inches.

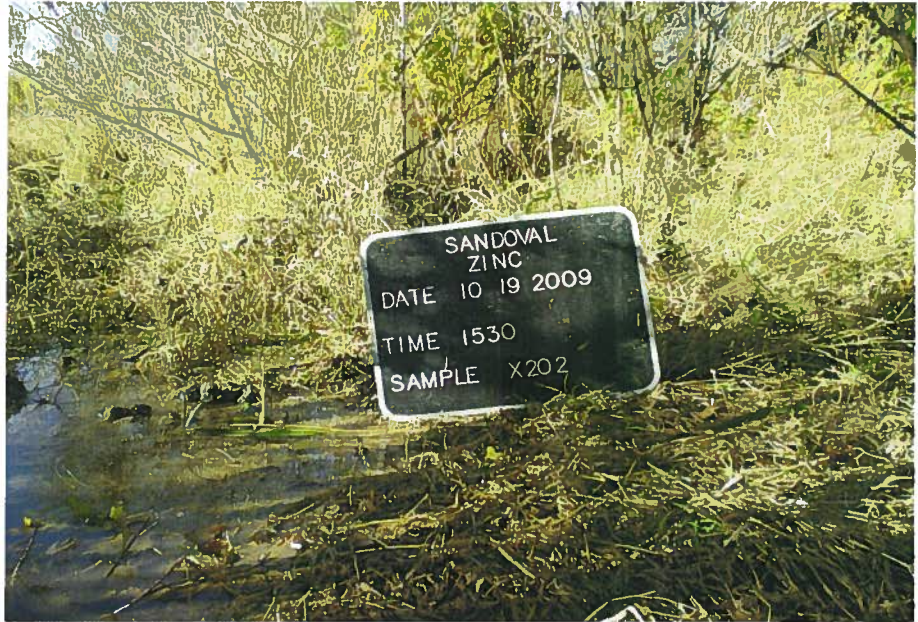
DATE: 10/19/2009
TIME: 1530
PHOTO BY: L. Range
DIRECTION: North

This photo was taken of sample location X202. X202 was collected from a low lying area in which drainage from wetlands was present. X202 was collected from a depth of 8 inches from a brown silty sediment.

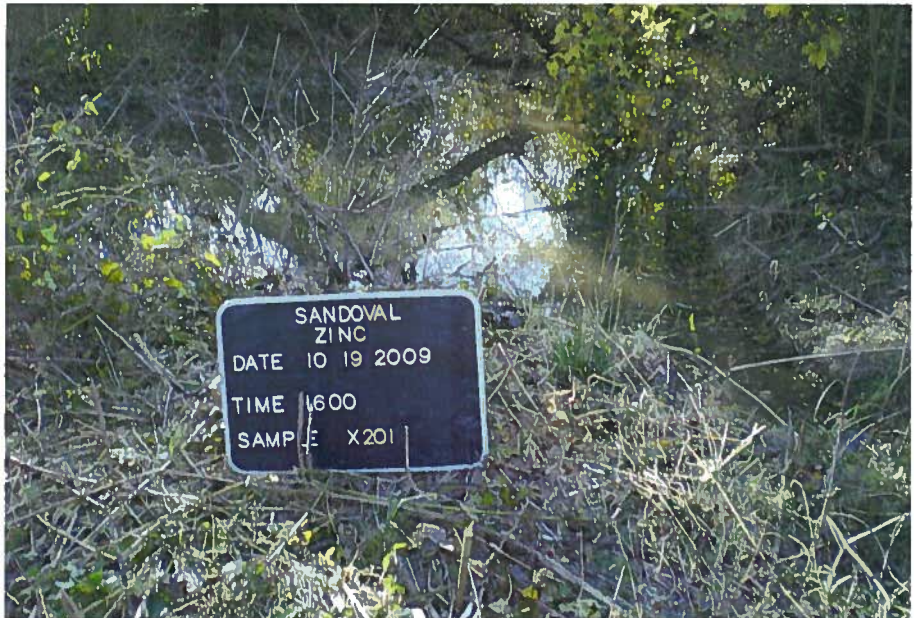
DATE: 10/19/2009
TIME: 1600
PHOTO BY: L. Range
DIRECTION: South

Photo taken at 1600 of sample X201. X201 was collected at the confluence of one of the surface water pathways as it enters into Prairie Creek. X201 was collected from a brown silt from a depth of 0-3 inches.

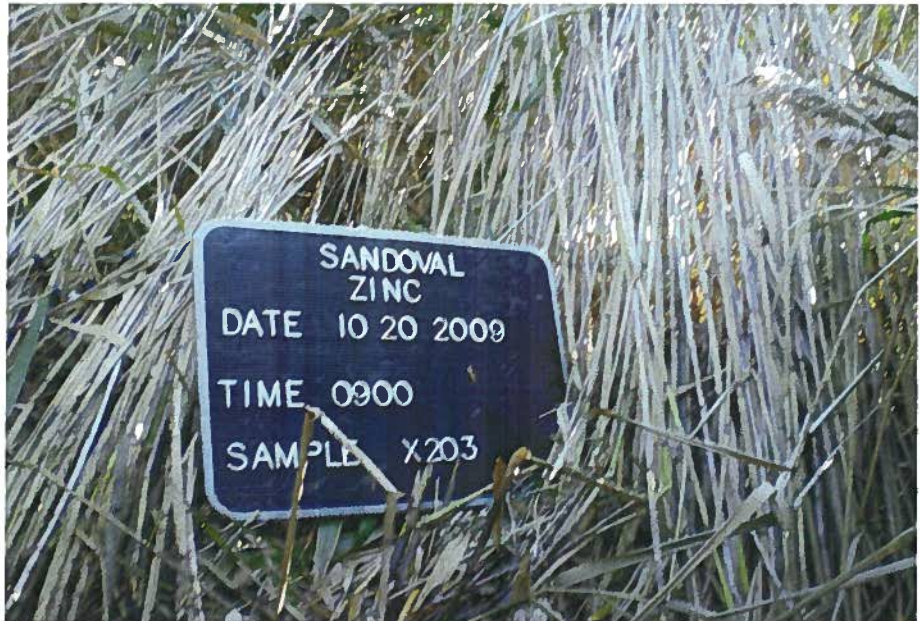
DATE:	10/20/2009
TIME:	0900
PHOTO BY:	L. Range
DIRECTION:	East
COMMENTS:	<p>Photo taken of sample location X203. Phragmites present everywhere. Sample was collected from the deepest area of the drainage area in the wetland. X203 consisted of a slightly gritty slightly sandy clay. Sample was collected from a depth of 8 inches.</p>

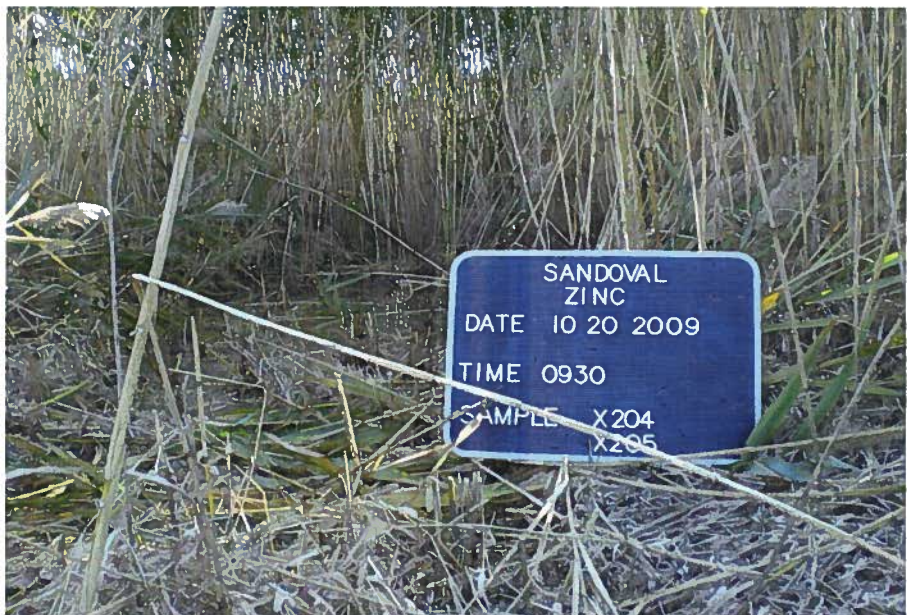
DATE:	10/20/2009
TIME:	0930
PHOTO BY:	L. Range
DIRECTION:	East
COMMENTS:	<p>Photo taken of Sample X204 and X205 duplicate. Sample location was within the wetlands. Sample was collected from lowest portion of the wetlands in this area. Sample was collected from a depth of 12 to 16 inches from a light brown sandy silt with some clay.</p>

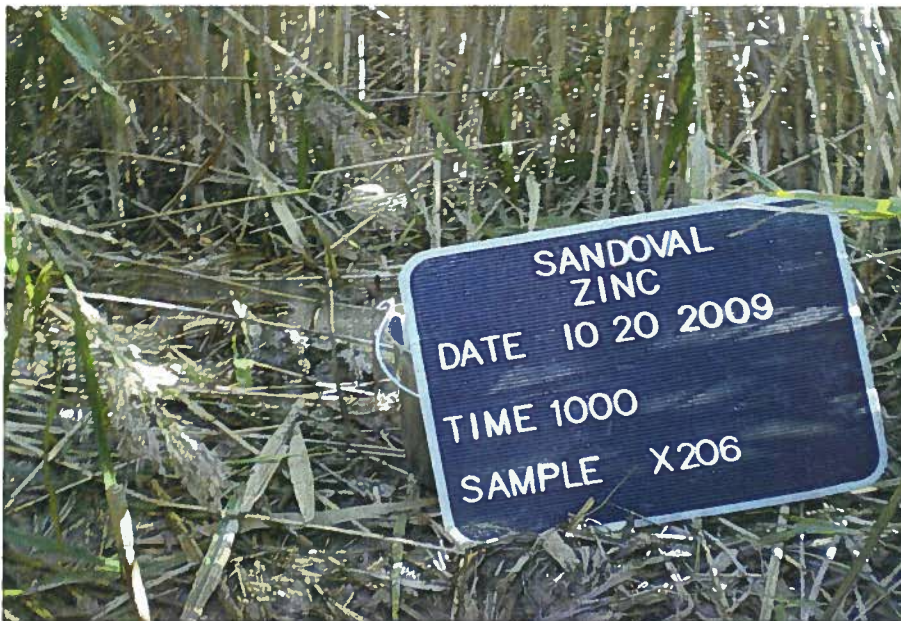
DATE: 10/20/2009
TIME: 1000
PHOTO BY: L. Range
DIRECTION: East

Photo was taken of sample location X206. X206 was collected from the wetland area. X206 consisted of a brown silt with some grit from a depth of 8-10 inches. This location is near the four wheeler crossing southeast of the site.

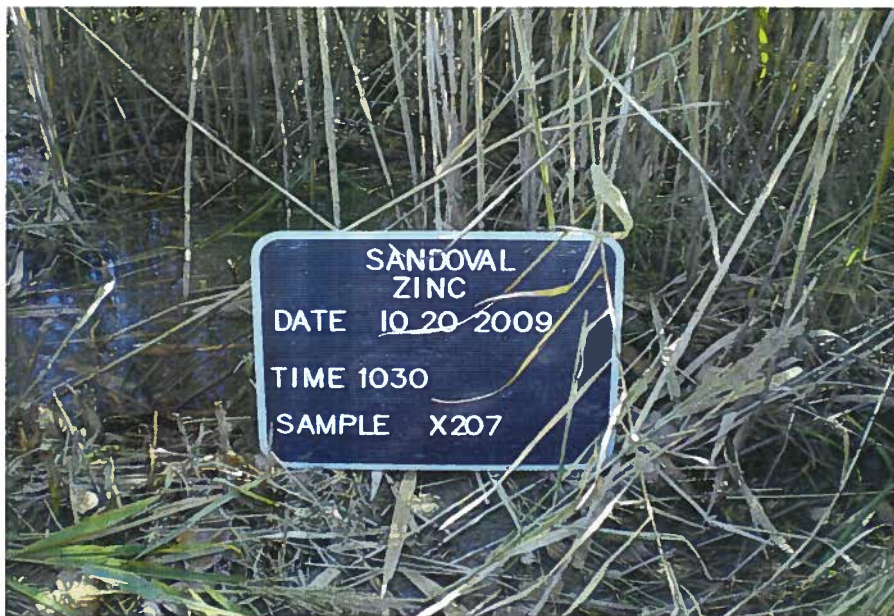
DATE: 10/20/2009
TIME: 1030
PHOTO BY: L. Range
DIRECTION: Southeast

Photo was taken of sample location X207. X207 was collected from a lowlying area within the wetlands. This location was at the east side of the four wheeler path. X207 was collected from a brown silt with some clay and grit from a depth of 6 inches.

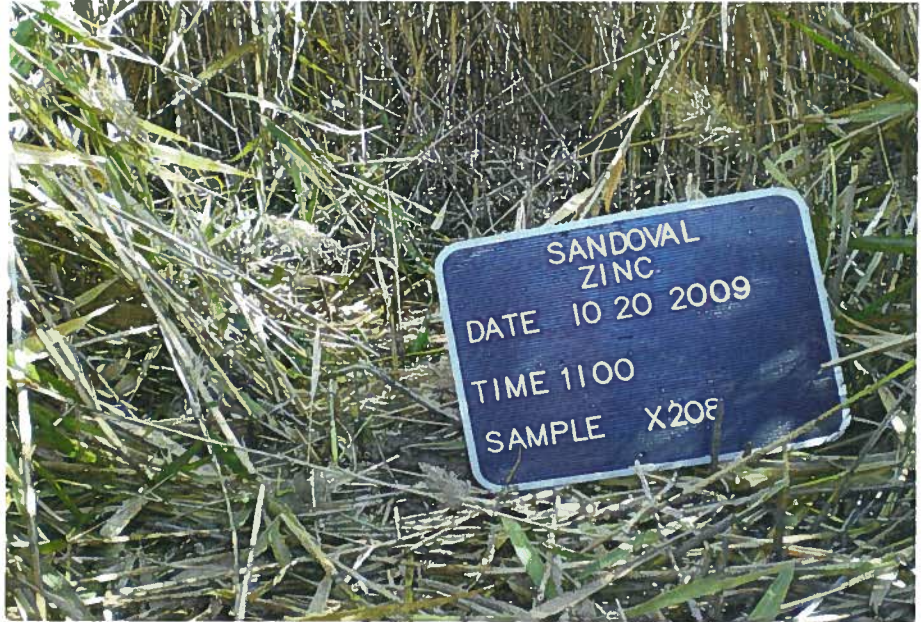
DATE:	10/20/2009
TIME:	1100
PHOTO BY:	L. Range
DIRECTION:	East
COMMENTS: Photo taken of sample location X208 from the wetland area. X208 consisted of a silty sand with many roots from the phragmites from a depth of 8 inches.

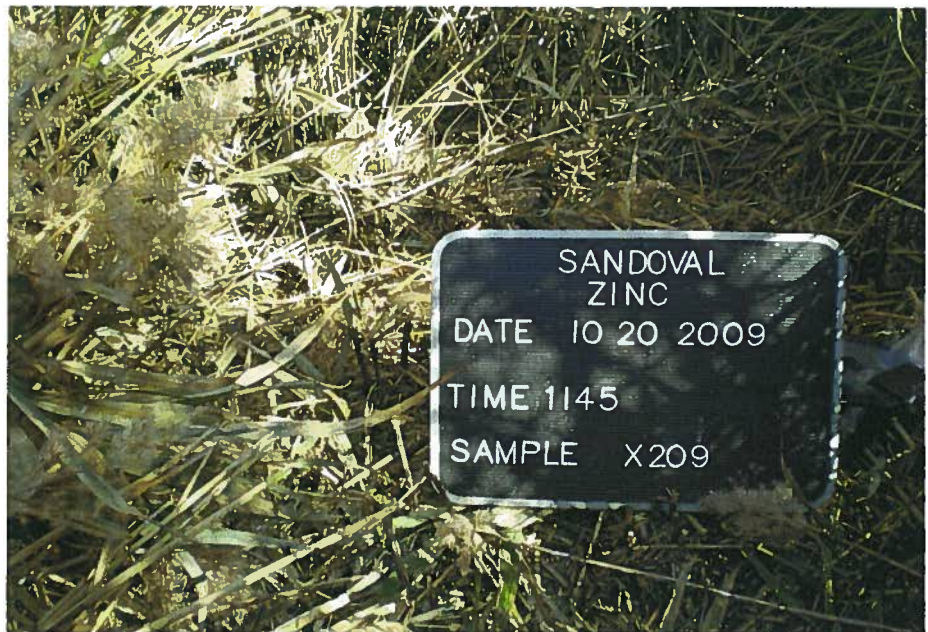
DATE:	10/20/2009
TIME:	1145
PHOTO BY:	L. Range
DIRECTION:	Northeast
COMMENTS: Photo taken of sample location X209. X209 was collected from low lying wetlands. X209 consisted of a brown gritty silt from a depth of 10-12 inches.

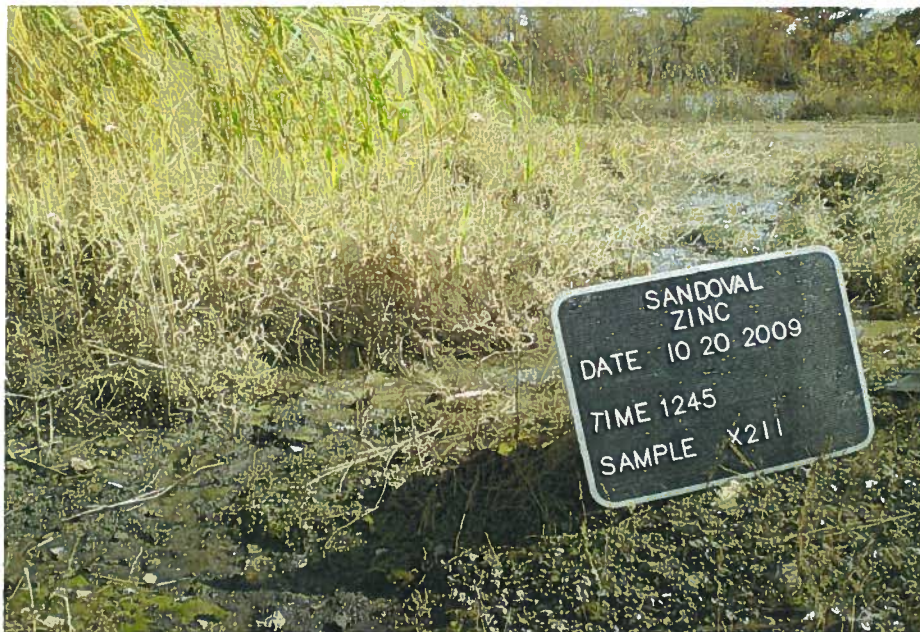
Photo taken of sample location X211. X211 was located at the confluence of drainage from the site to the wetlands located along the eastern edge of the property. X211 consisted of a brown silt with cinders. Collected from a depth of 0-3 inches.

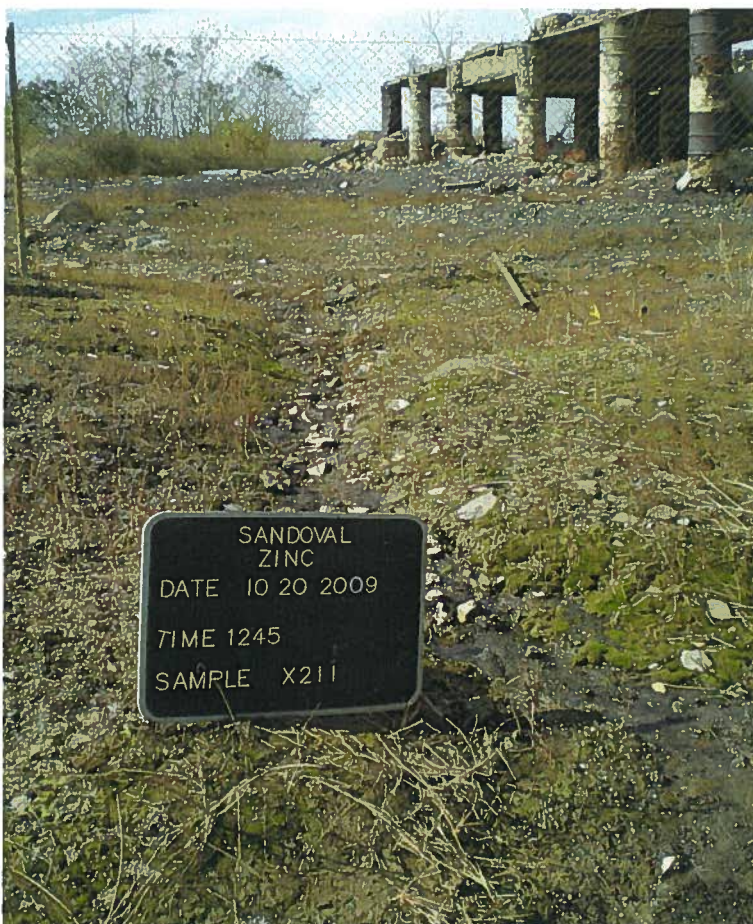
DATE: 10/20/2009
TIME: 1245
PHOTO BY: L. Range
DIRECTION: West

Photo taken of sample location X211. X211 was located at the confluence of drainage from the site to the wetlands located along the eastern edge of the property. X211 consisted of a brown silt with cinders. Collected from a depth of 0-3 inches. Showing drainage from site.

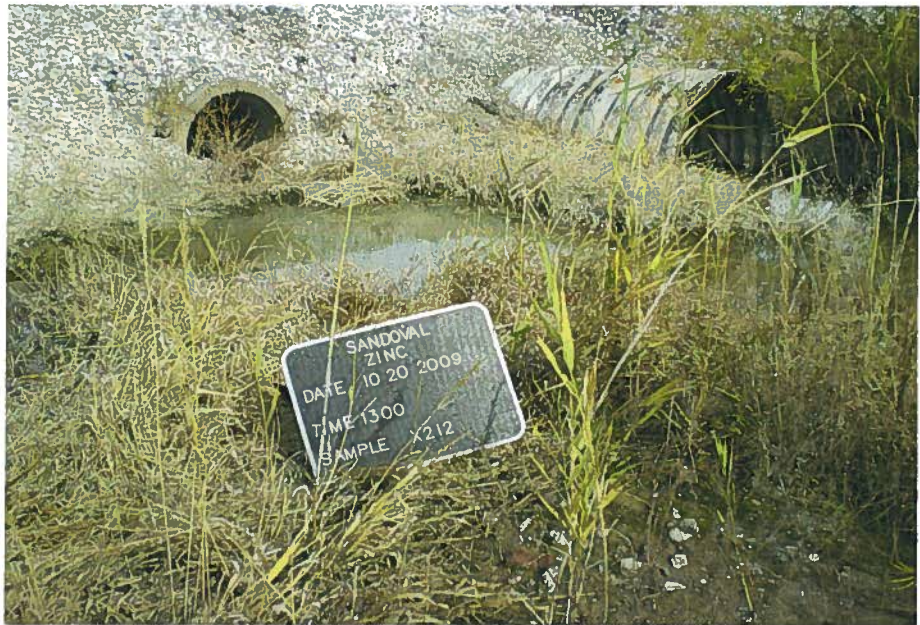
DATE: 10/20/2009
TIME: 1300
PHOTO BY: L. Range
DIRECTION: North

Photo taken of sample location X212. X212 was located in the area of confluence of the drainage from the north side of the property to the wetland area. X212 consisted of a gritty brown silt and was collected from a depth of 0-3 inches.

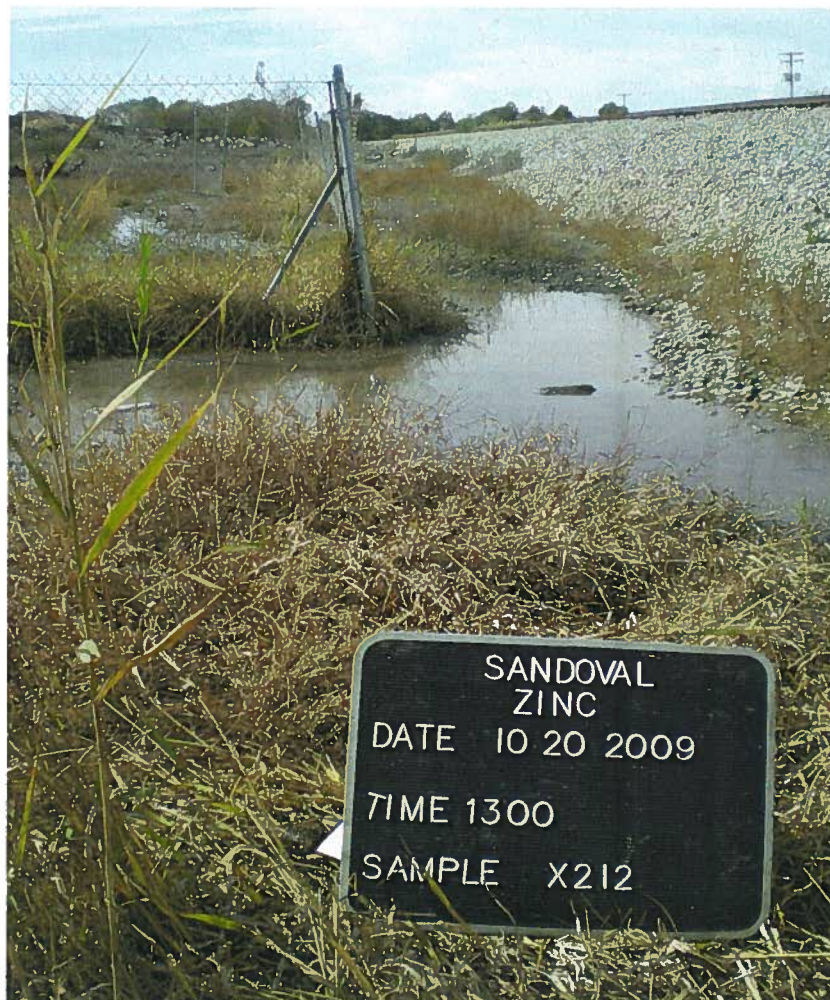
DATE: 10/20/2009
TIME: 1300
PHOTO BY: L. Range
DIRECTION: West

Photo taken of sample location X212. X212 was located in the area of confluence of the drainage from the north side of the property to the wetland area. X212 consisted of a gritty brown silt and was collected from a depth of 0-3 inches.

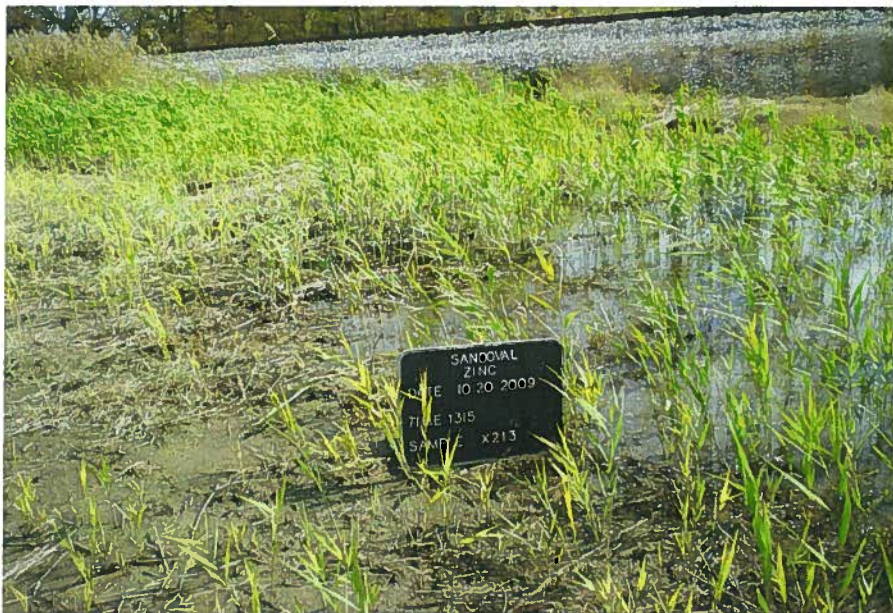
DATE: 10/20/2009
TIME: 1315
PHOTO BY: L. Range
DIRECTION: Southeast

Photo taken of sample location X213. X213 was located on the north side of the tracks from an area which was discharging surface water from the west towards the drainage pipes which pass under the RR tracks. X213 consisted of a light brown silt collected from 0-3 inches.

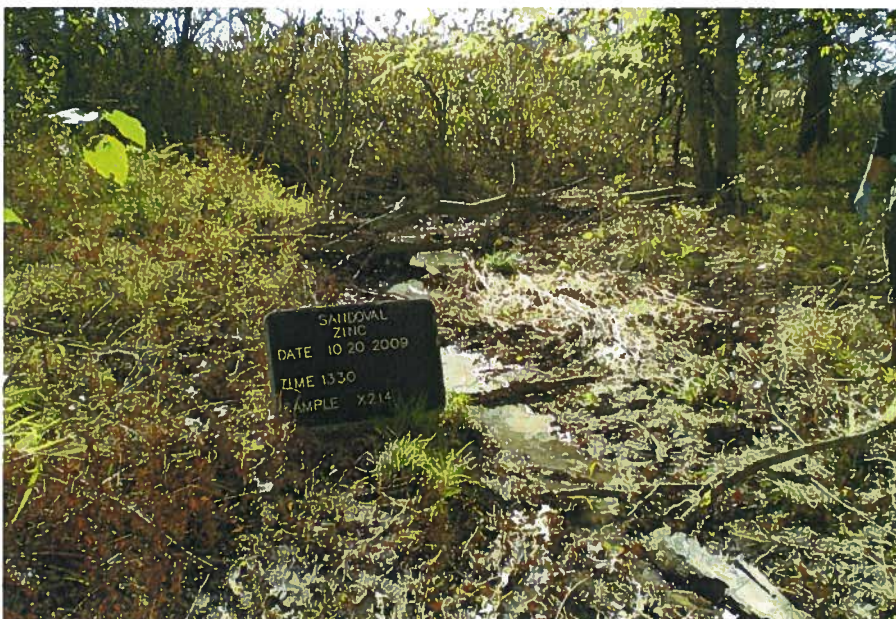
DATE: 10/20/2009
TIME: 1330
PHOTO BY: L. Range
DIRECTION: South

Photo taken of sample location X214. X214 was located from a wooded area located upstream from the site. Sample consisted of a brown silt. Sample was collected from a depth of 0-2 inches.

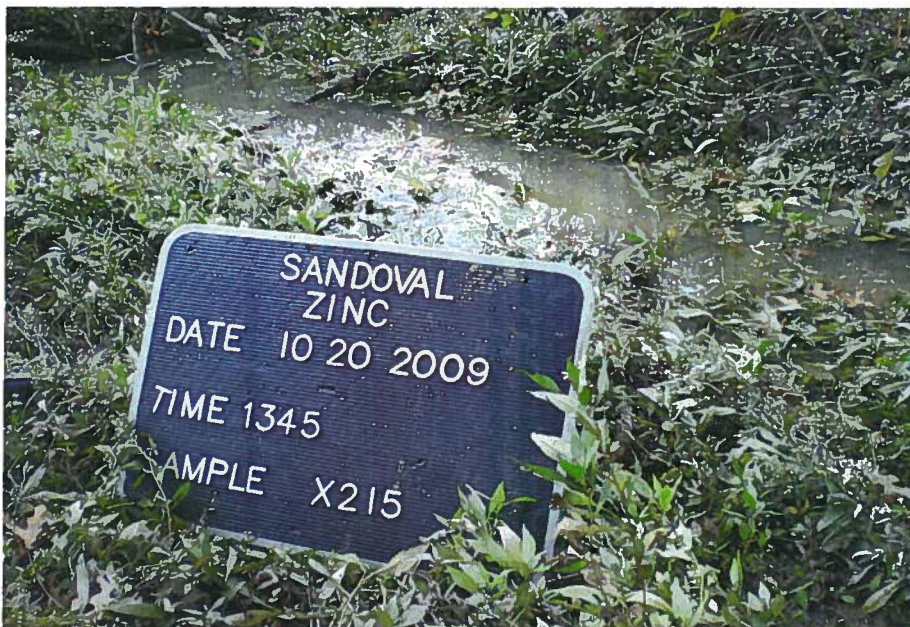
DATE: 10/20/2009
TIME: 1345
PHOTO BY: L. Range
DIRECTION: Southwest

Photo taken of sample location X215. X215 was located upstream of the site in a wooded area. X215 consisted of a brown silt collected from a depth of 0-3 inches.

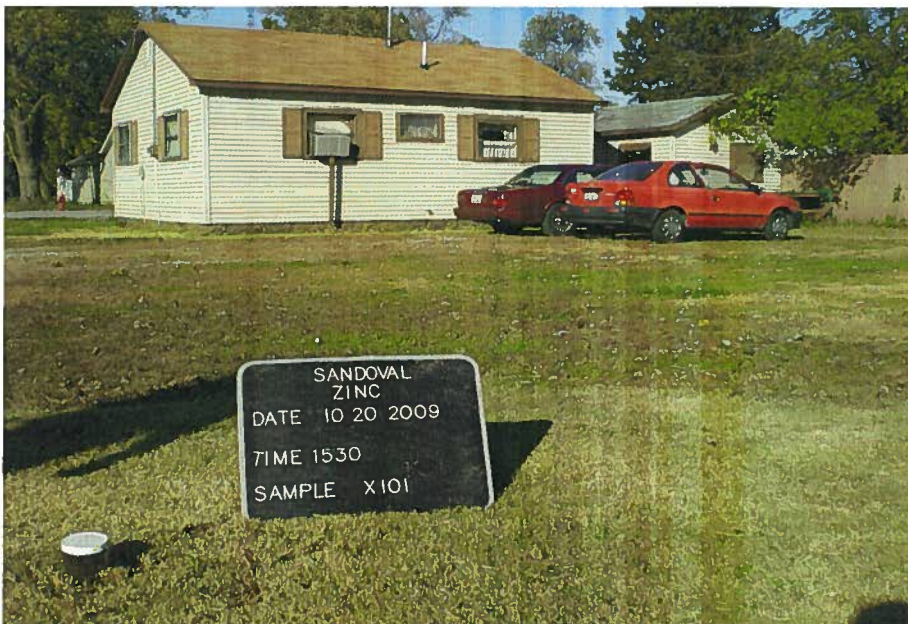
DATE: 10/20/2009
TIME: 1530
PHOTO BY: L. Range
DIRECTION: Northeast

This photo was taken of sample location X101. This sample was collected from a residential yard. X101 was located at the southwest corner of the property from a black cindery material from a depth of 4 inches.

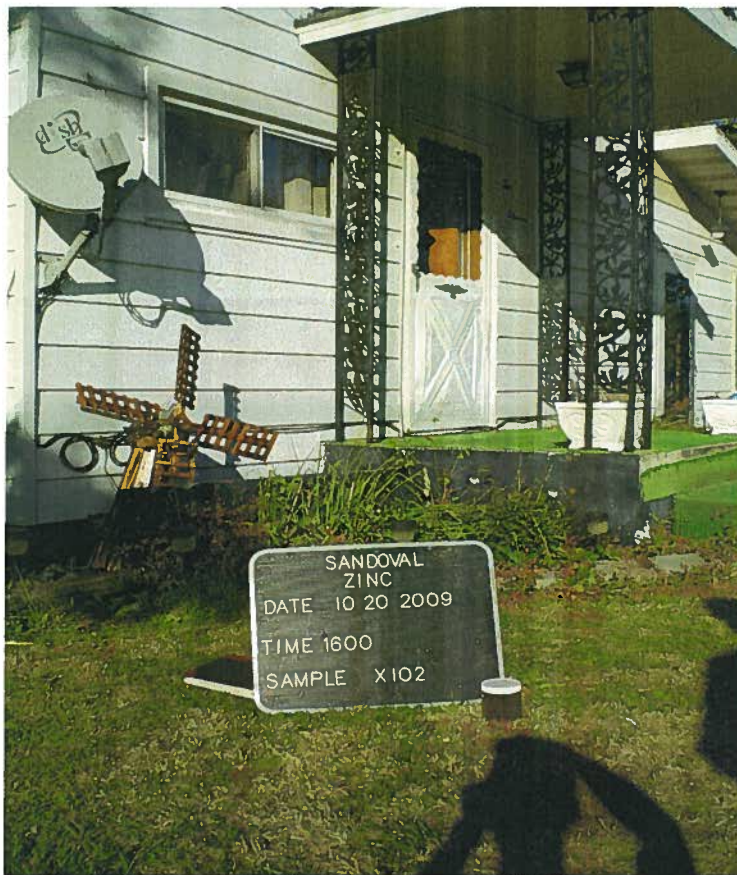
DATE: 10/20/2009
TIME: 1600
PHOTO BY: L. Range
DIRECTION: Northeast

Photo was taken of sample location X102. X102 was located at the southwest corner of the home. Sample consisted of a sandy brown loam and was collected from a depth of 4 inches.

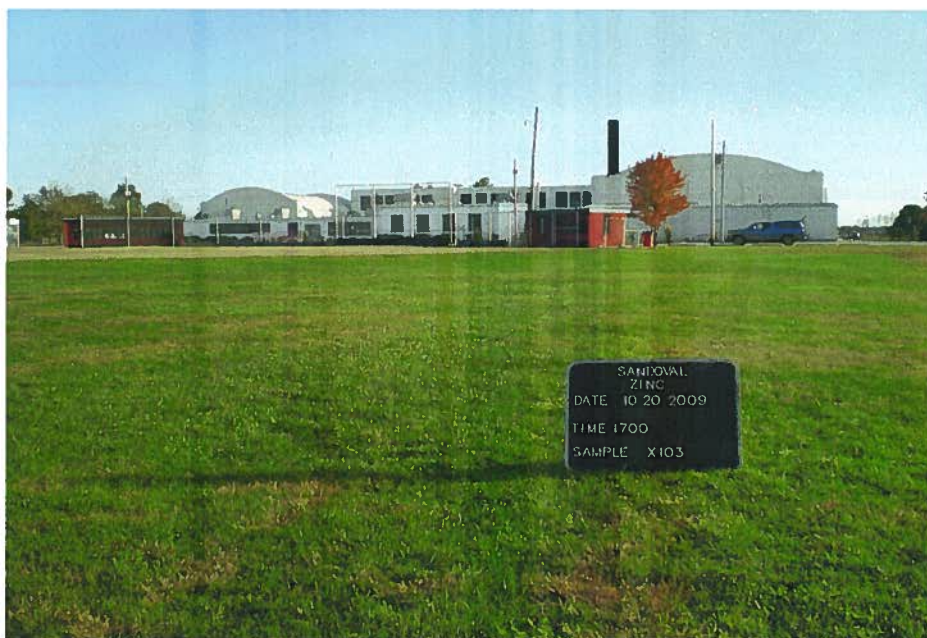
DATE: 10/20/2009
TIME: 1700
PHOTO BY: L. Range
DIRECTION: South

Photo taken of sample X103. This sample was located in the former football field located to the north of the Jr/Sr High School. X103 was collected from a depth of 4 inches from a brown loam, which was just under a peat type layer.
